FACILITY COMPLIANCE INSPECTION REPORT

Division of Waste Management Solid Waste Section

Date of Site Inspection: April 1, 2014

Inert Disposal (Stump Dump) LCID Landfill
 1017 Center Grove Church Road
 Moncure, NC 27559

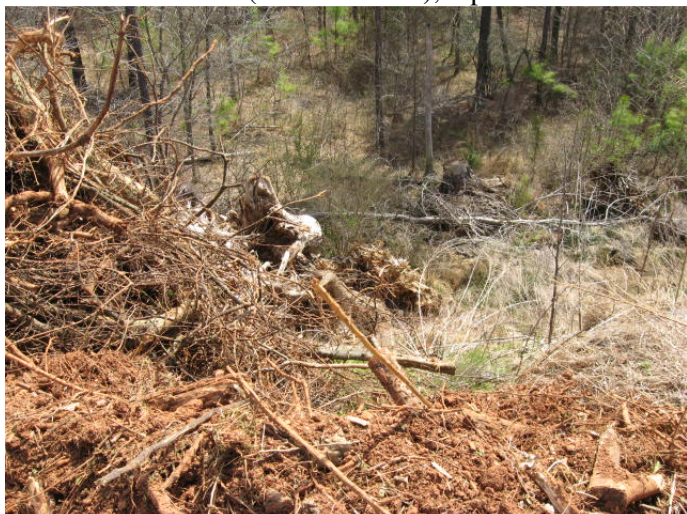
LCID to be covered (recent and old), representative

- e. Post signage identifying the operations: LCID landfill and inert debris storage area.
 - f. Ensure LCID older than 30 days (rear side slope) is adequately covered with soil within 14 days of receipt of this inspection report.

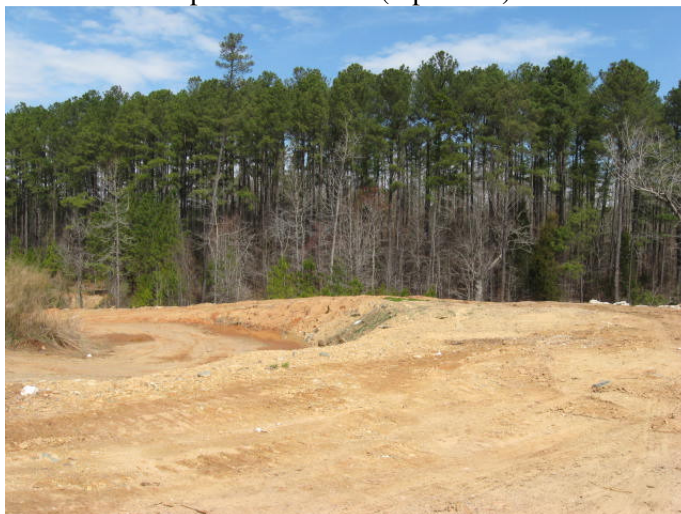
Soil cover atop LCID landfill (top – rear)

10. Per 15A NCAC 13B .0566(4), "Adequate soil cover shall be applied monthly, or when the active area reaches one acre in size, whichever occurs first."

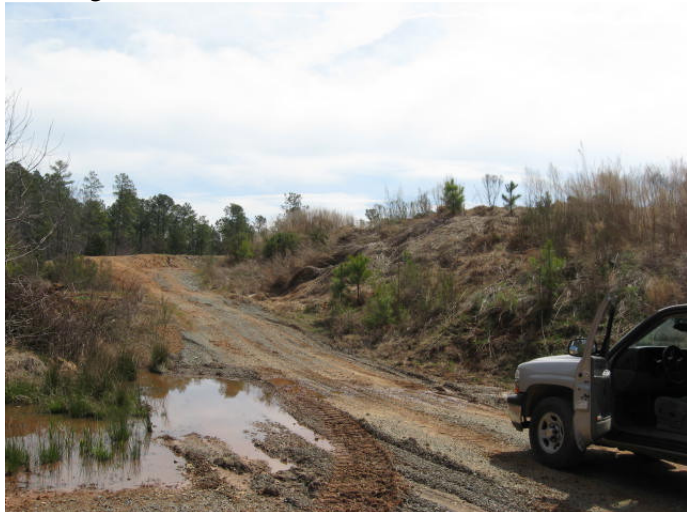
Ponding of water – LCID landfill area entrance

- g. Ensure areas of ponded water are filled and graded accordingly.
 - h. Submit an update land clearing and inert debris landfill notification to the SWS referencing: property owner, contact information, facility name, etc. within 30 days of receipt of this inspection report.

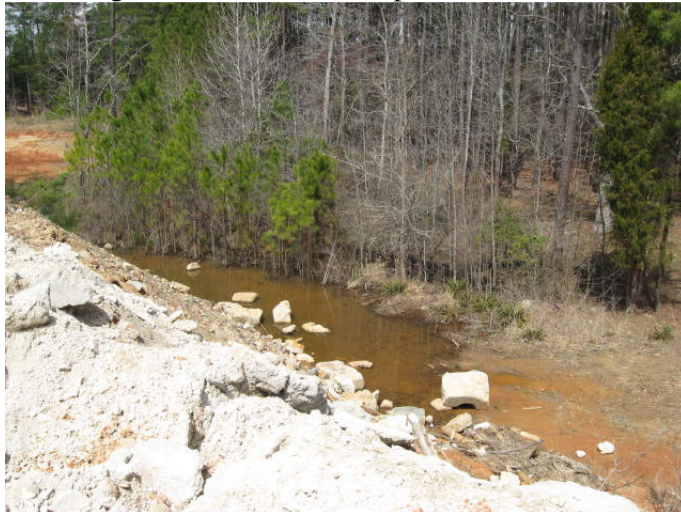
Ponding of water – left side slope at LCID landfill

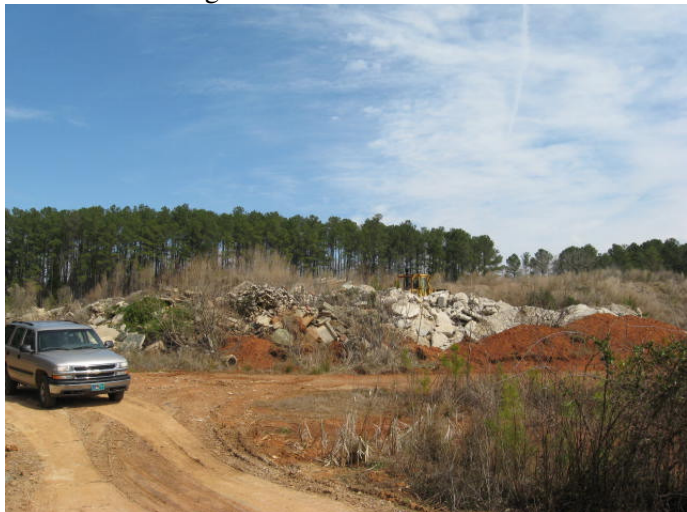
Inert debris storage area

- c. Edge of waste markers shall be installed at the LCID landfill.
 - d. Provide this office with a description of the inert debris storage area [adjacent to the LCID landfill] within 30 days of receipt of this inspection report.

9. Per the inert debris storage area: Inert debris to be stored for future use shall be piled and/or graded such that water does not pond. Inert debris to be used on site shall be covered with soil and graded accordingly. Inert debris mixed with soil shall be covered with a layer of soil and graded accordingly or placed in the LCID landfill.

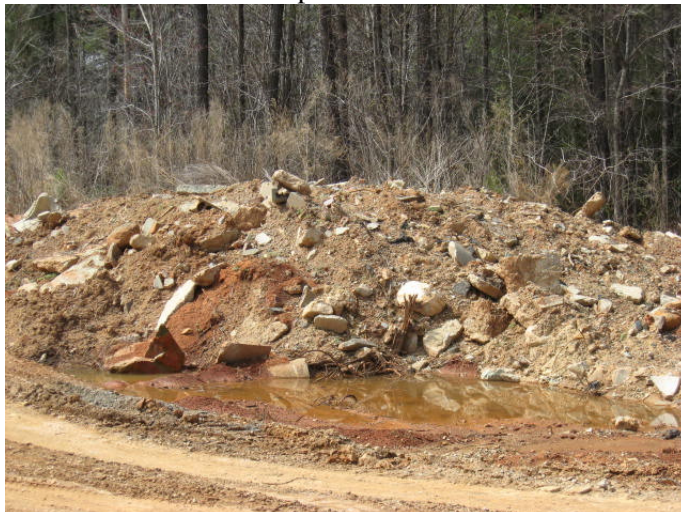
Inert debris and soil w/ponded water

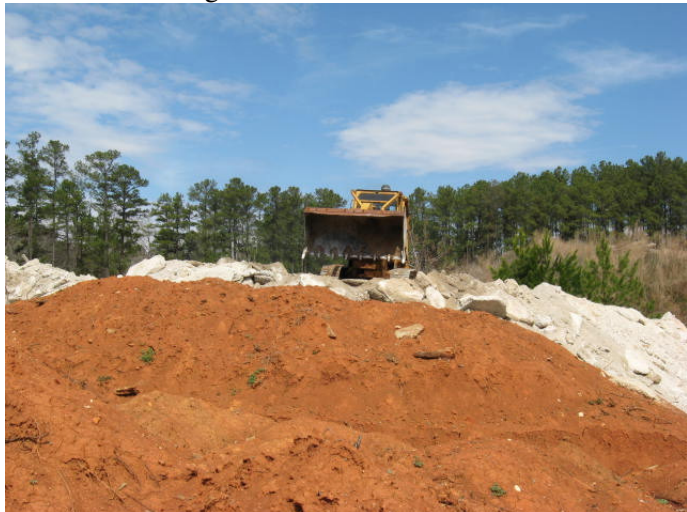
Inert debris storage area w/borrow soil

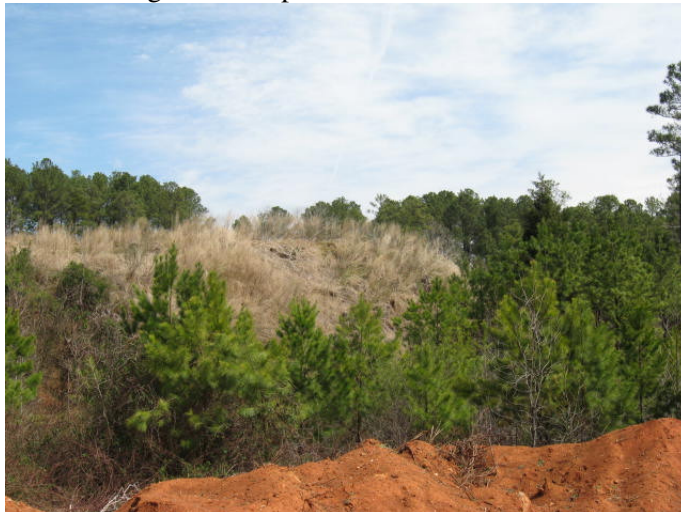
View of right side slope of LCID landfill

11. Side slopes should be graded and covered with soil such that a 3:1 slope ratio is obtained or a ratio of which no indication of erosion or runoff is observed.
